# Safety Alert

RSA-2015-01

#### **Identification of asbestos gasket in coal wagon valves**

## Identification of Asbestos Gasket in Coal Wagon Valves

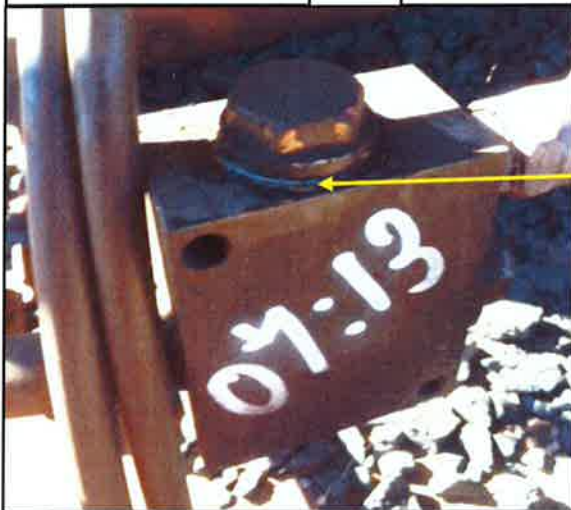
Faiveley Check Valve (CV 010)

The gaskets are almost completely enclosed within the valves (see Photo). The potential for free asbestos fibres to be released and inhalation of fibres from the gasket is considered **extremely low**.

New Gasket Material

Green Colour = **Safe**

Old Gasket Material

Red Colour = **Do Not Work On**

Location of Gasket Material

Colour able to be determined

The gaskets in position pose minimal risk. Where the gaskets are becoming inefficient or faulty they are **NOT** to be repaired. A complete change out of the valve is to occur.

Once the valve is removed it is to be placed in a plastic bag, sealed using adhesive tape and isolated in a safe location. In due course the valves will be disposed of as contaminated waste.
