Safety Alert

RSA-2015-01

Identification of asbestos gasket in coal wagon valves

Identification of Asbestos Gasket in Coal Wagon Valves

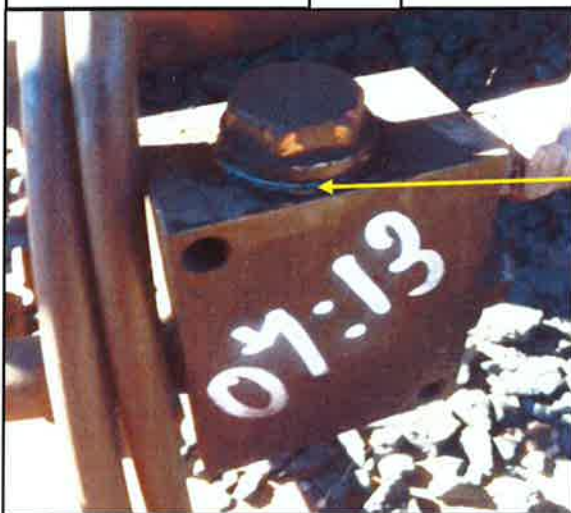
Faiveley Check Valve (CV 010)

While undertaking a SM on a Coal wagon a maintainer identified a “Red” colour gasket in a **Faiveley Check Value (CV010)**. The employee was suspicious of the material the gasket may have been made of.

The gasket was sent to a NATA Accredited laboratory for analysis. The testing showed the presence of Chrysotile Asbestos.

The gaskets are almost completely enclosed within the valves (see Photo). The potential for free asbestos fibres to be released and inhalation of fibres from the gasket is considered **extremely low**.

New Gasket Material

Green Colour = **Safe**

Old Gasket Material

Red Colour = **Do Not Work On**

Location of Gasket Material

Colour able to be determined

The gaskets in position pose minimal risk. Where the gaskets are becoming inefficient or faulty they are **NOT** to be repaired. A complete change out of the valve is to occur.

Once the valve is removed it is to be placed in a plastic bag, sealed using adhesive tape and isolated in a safe location. In due course the valves will be disposed of as contaminated waste.
