# Safety Alert

RSA-2014-02

#### Thermal (or Metal) Spraying of Axles

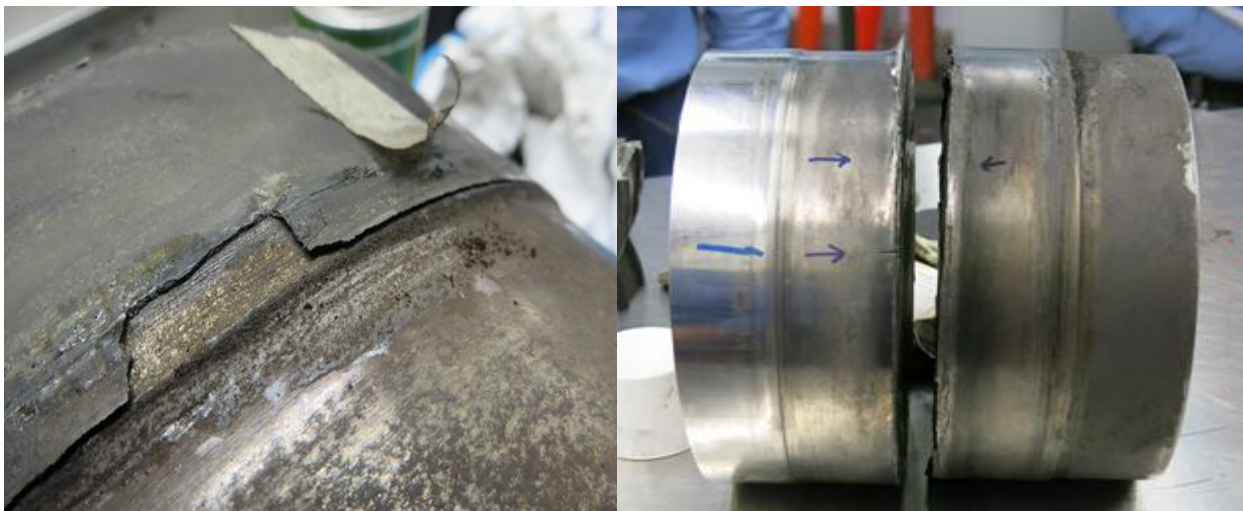
A major passenger operator recently suffered an axle failure on one of its electric multiple unit (EMU) fleet. Approximately fourteen (14) years prior, the axle in question had been subjected to thermal spraying on the gearbox bearing and oil thrower surfaces.

Indications that surface preparations used to promote proper bonding of the coating material resulted in minor circumferential grooving around the axle barrel which acted as origins for fatigue initiation. Although the rate of crack propagation was very low, the numerous fatigue initiators coupled with the fact that these were aligned (i.e. as in a continuous groove), eventually resulted in a fracture surface that was perpendicular to the longitudinal axis.

**The above images depict the circumferential grooving and partial delamination of the metal coating and matched fracture surfaces**

Rail Transport Operators may need to review and revise their current risk registers (and the associated standards and work procedures) in order to manage to a SFAIRP level, the hazards associated with an axle failure (other than at the journal bearing seat) due to thermal spraying.

In addition, due consideration needs to be given to the inherent limitations of non-destructive testing (NDT) and other inspection methods to detect the existence of any fatigue initiators on the metal sprayed axle surfaces during the scheduled inspection and maintenance interventions.
