Safety Bulletin

Preventing unbraked runaways of permanently coupled wagons with shared braking platforms

No. 4 – November 2014

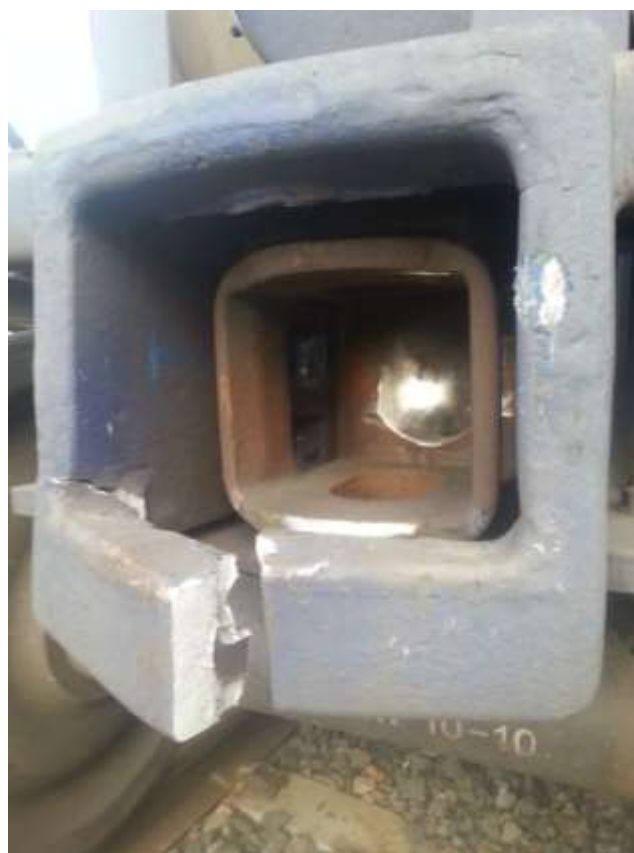
- Train partings caused by component failures often relate to a failure of the yoke, which can be due to casting defects, inadequate fracture toughness properties or a single gross overload event, to name a few. Yoke pin failures, although rare, have also resulted in train partings.
- Two wagons permanently coupled together with shared brake equipment can be marshalled as the trailing vehicles in a train consist.

An example of a fractured yoke on a solid drawbar assembly is pictured below.

- The basis on which inspection and maintenance regimes of drawbar coupler assemblies and associated individual components on permanently coupled wagons, have been determined to be managing the risk of train parting.
- How the design of the braking system incorporates additional controls to mitigate a separation between permanently coupled wagons which share a common braking system platform.

Depending on their operating environments, rail transport operators may need to review and revise current risk registers in order to manage to a SFAIRP level the risk associated with a solid drawbar assembly between wagons sharing a common braking system.
