Safety Alert

NOTICE TO RAIL TRANSPORT OPERATORS

RSA-2013-02 Date Issued 18 November 2013

Coupling Systems and Brake Systems Fitted to Infrastructure Trolleys and Trailers

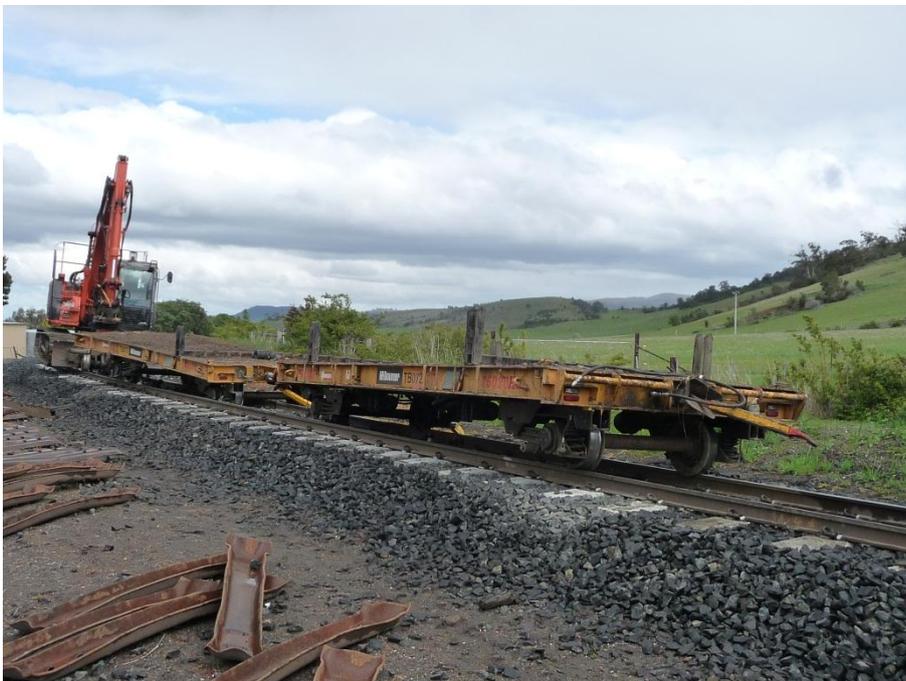
On 9 November 2013 as a result of the derailment of a rail mounted excavator, the two trailers which it was towing became detached and ran away, subsequently colliding with a second rail mounted excavator which was located 6 kilometers away from the original derailment site.

Figure 1: Point of collision

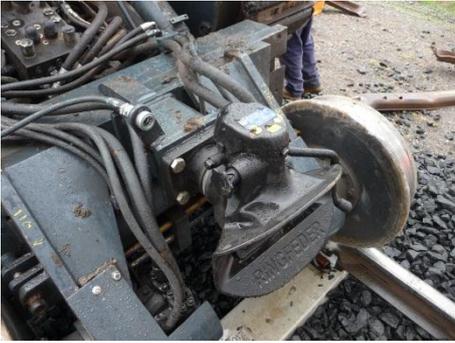
The coupling between the excavator and trailer was a "Ringfeder" type typically found on heavy road vehicles. The operator advises preliminary enquiries reveal a size mismatch between the drawbar ring and the Ringfeder pin of approximately 10mm. The pin was therefore not fully engaged in the drawbar ring and only became dislodged when the excavator de-railed when travelling at approximately 5km/h.

Figure 2: Ringfeder type coupler

1. Examine the adequacy of coupling arrangements to prevent unintended parting.
2. Undertake a thorough evaluation of braking systems to ensure vehicles, trailers, trolleys etc. do not enter an un-braked state in the event of separation. Additionally, ensure the vehicle’s brake system will stop and hold the fully loaded vehicle stationary on the ruling grade and in all weather and track

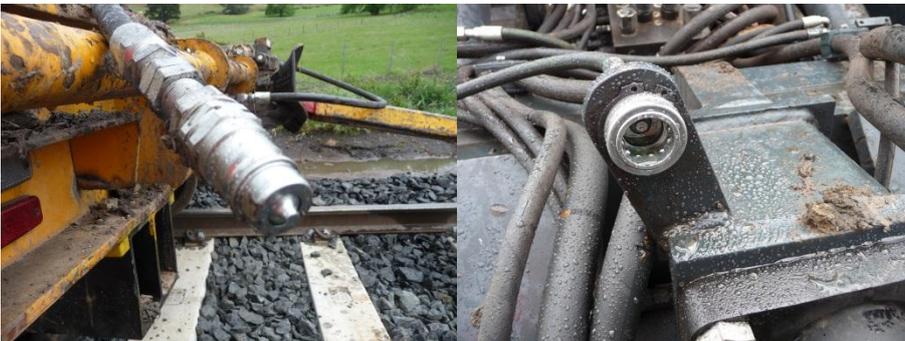
In this incident, once the trailers became separated from the excavator the hydraulic line separated at the “breakaway coupling”, however the ball (or poppet) valve inside each side of the fittings maintained hydraulic pressure in the trailer’s brake line which kept the trailers’ brakes in the released position allowing them to roll away uncontrolled and in an un-braked condition.

The operator advises the excavator should have been fitted with a locking hydraulic coupling (not the “breakaway coupling” as found on the machine at the time of the incident), so that the flexible hydraulic hose would tear, lose hydraulic pressure and apply the brakes in the event of separation. Both types of fitting are identical in appearance, the difference only detectable in the way they are engaged. The operator is currently investigating why the incorrect fitting was used on this machine.

Figure 3 and 4: Hydraulic coupling

3. Assess whether the use of hydraulic braking equipment, causing a spillage in case of separation is acceptable.
4. Ensure equipment new to their operation (including that provided by contractors and/or sub-contractors) is comprehensively assessed, tested and commissioned by a suitably qualified and competent person to ensure compatibility with other equipment it may be coupled to.
