ITSR Road/Rail Vehicle Workshop

V/Line Hi-Rail Project

October 2012

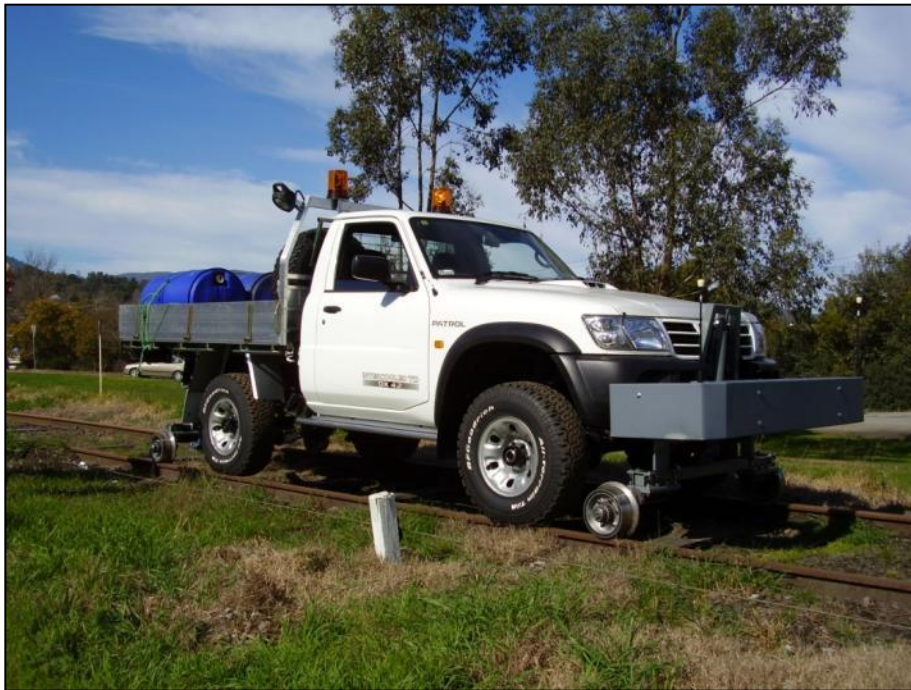
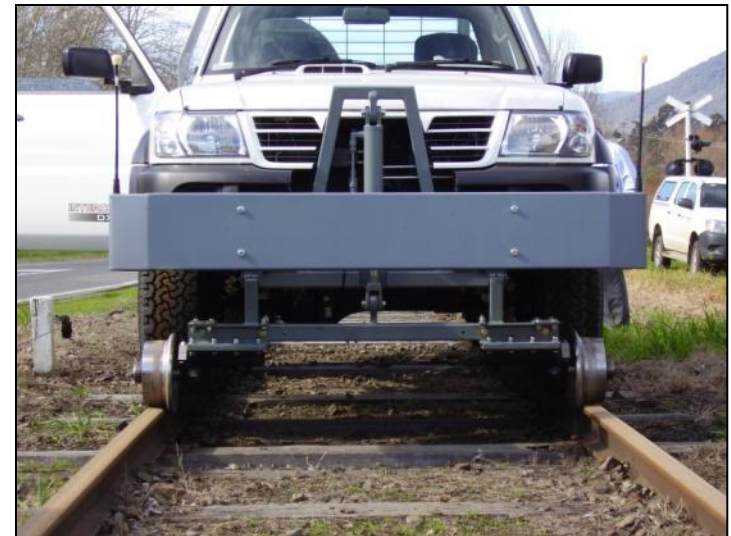
Rail Guidance fitted to light vehicles (“Track Inspector vehicles”)

The Fleet includes 29 light road rail vehicles used for track inspection.

The rail gear requires regular inspection and adjustment (4 month cycle)

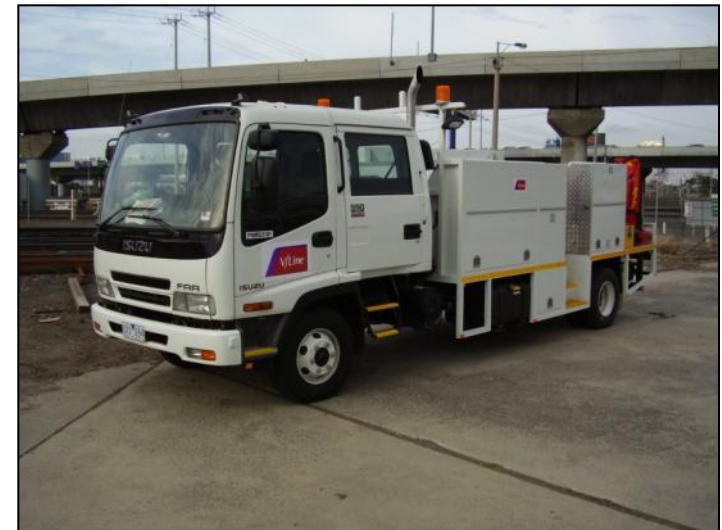
Hi rail Mobile Gang Truck

The RM Track maintenance group operates 18 'Mobile Gangs' through out the state each equipped with a set of engine powered tools

Night shift is becoming more common requiring better lighting and accessories.

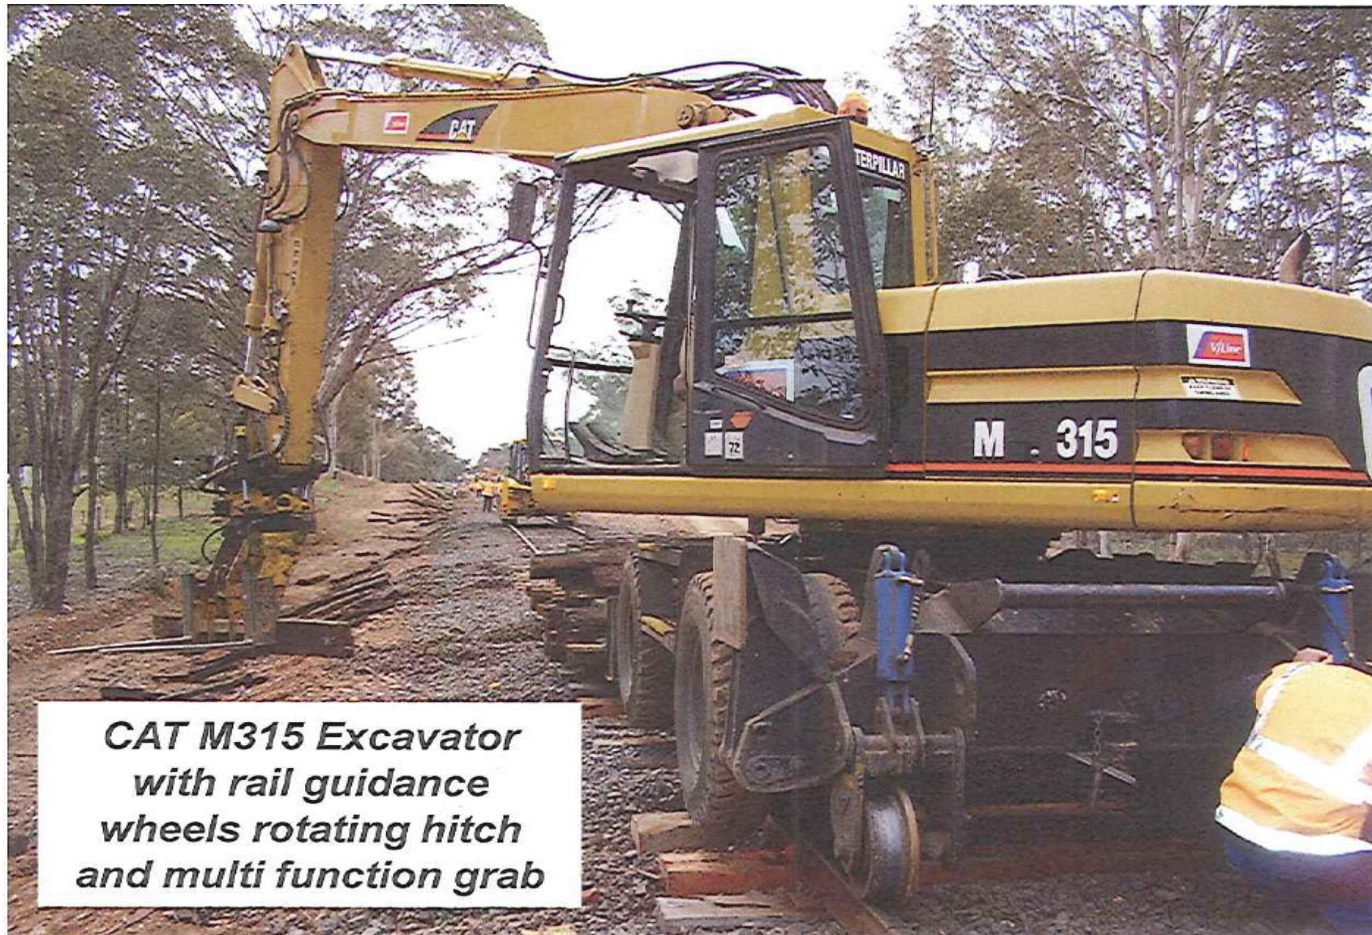
Rail Guidance fitted to wheeled excavator

***CAT M315 Excavator
with rail guidance
wheels rotating hitch
and multi function grab***

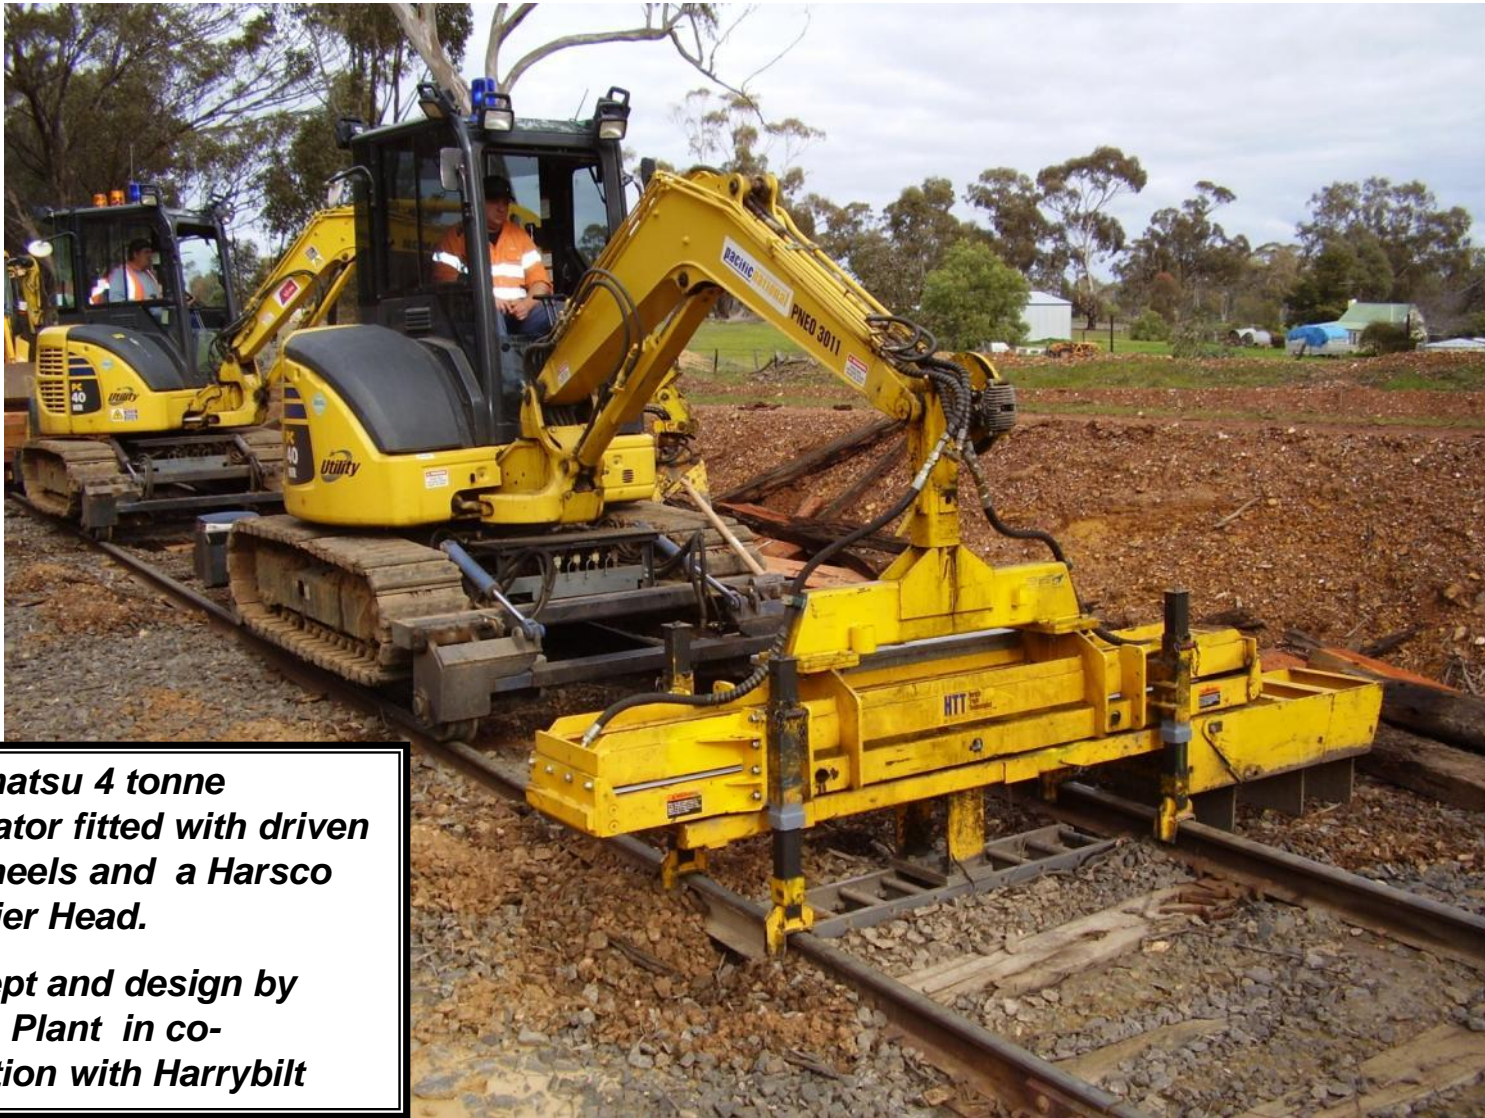
Rail Guidance fitted to tracked excavator

A Komatsu 4 tonne excavator fitted with driven rail wheels and a Harsco Scarifier Head.

Concept and design by V/Line Plant in co-operation with Harrybilt

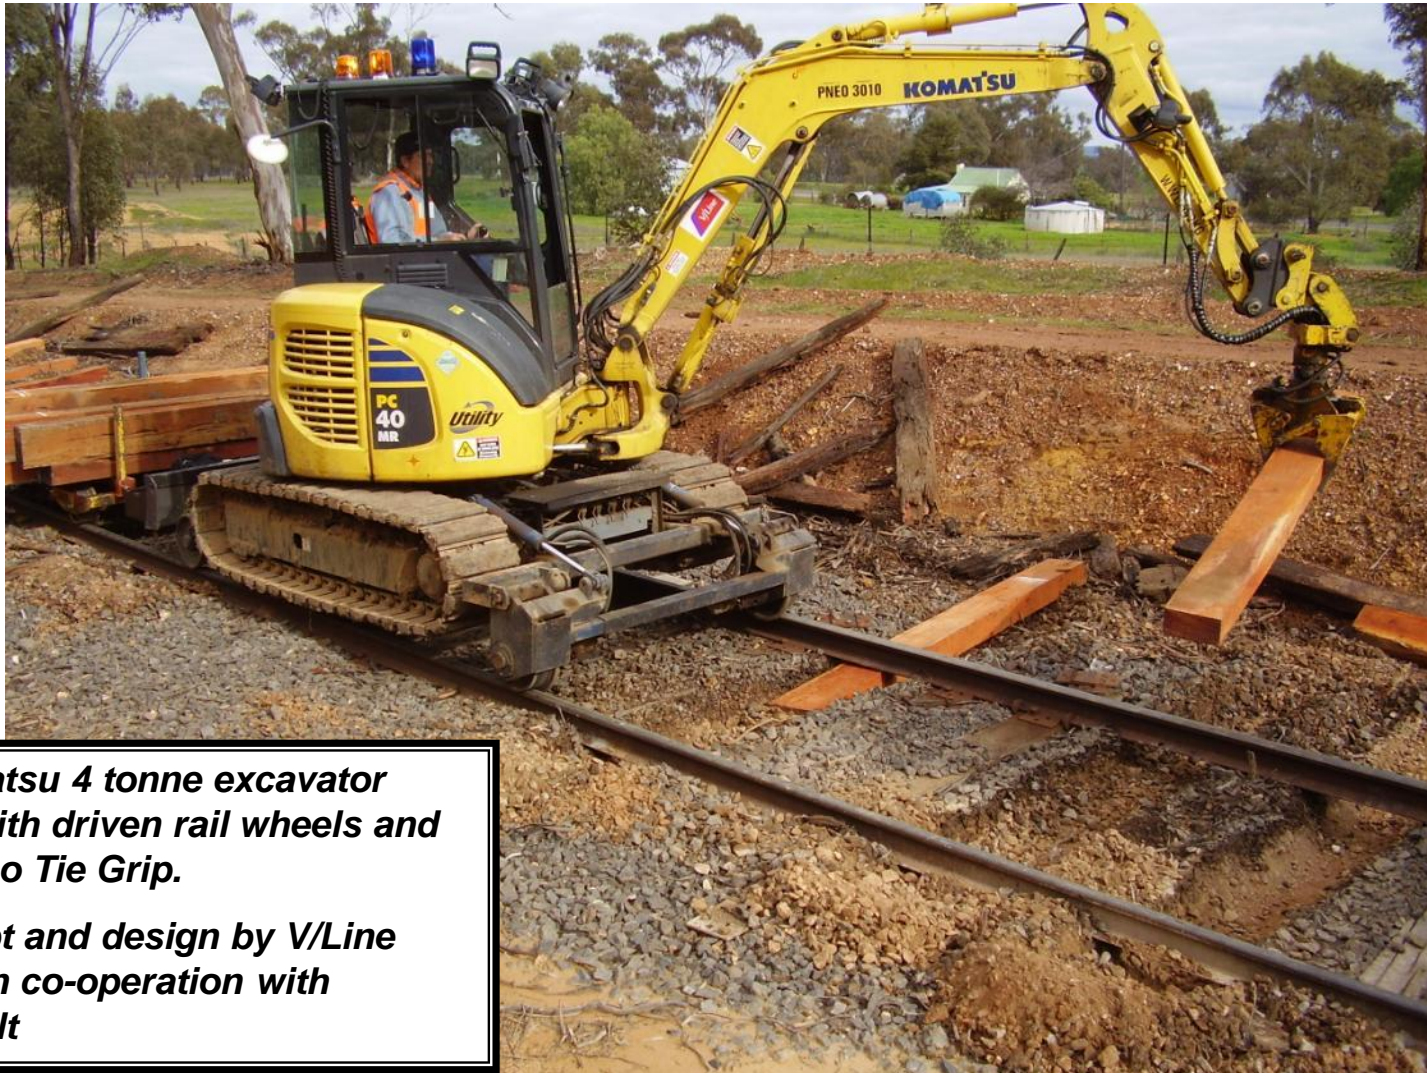
Rail Guidance fitted to tracked excavator

A Komatsu 4 tonne excavator fitted with driven rail wheels and a Harsco Tie Grip.

Concept and design by V/Line Plant in co-operation with Harrybilt
